Case 307 : Narrative

Case Vehicle (A): 1998 Ford	Veh. (B): 1996 Ford
Type: Windstar Limited, 4 x 2, minivan	Type: E-250 Econoline, 4 x 2, cargo van
Driver: 16-year-old male	Driver: 43-year-old male
CDC: 11-FDEW-4	CDC: 99-0000-0

Case No.: 307-02
Case Veh. (A): 1998 Ford
Type: Windstar Limited, 4 x 2, minivan
Driver: 16-year-old male
Veh. (B): 1996 Ford Econoline van

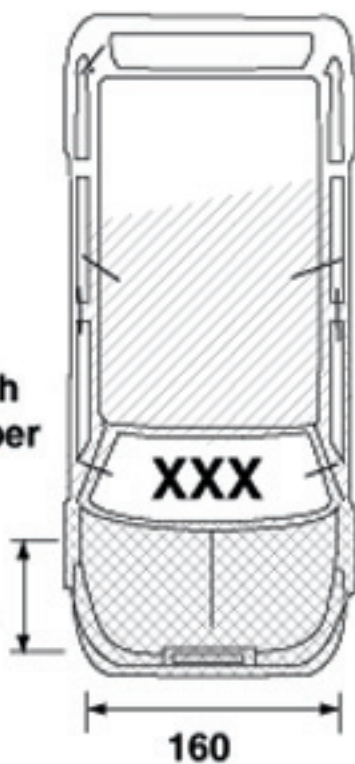
Max. crush to left upper radiator support

74

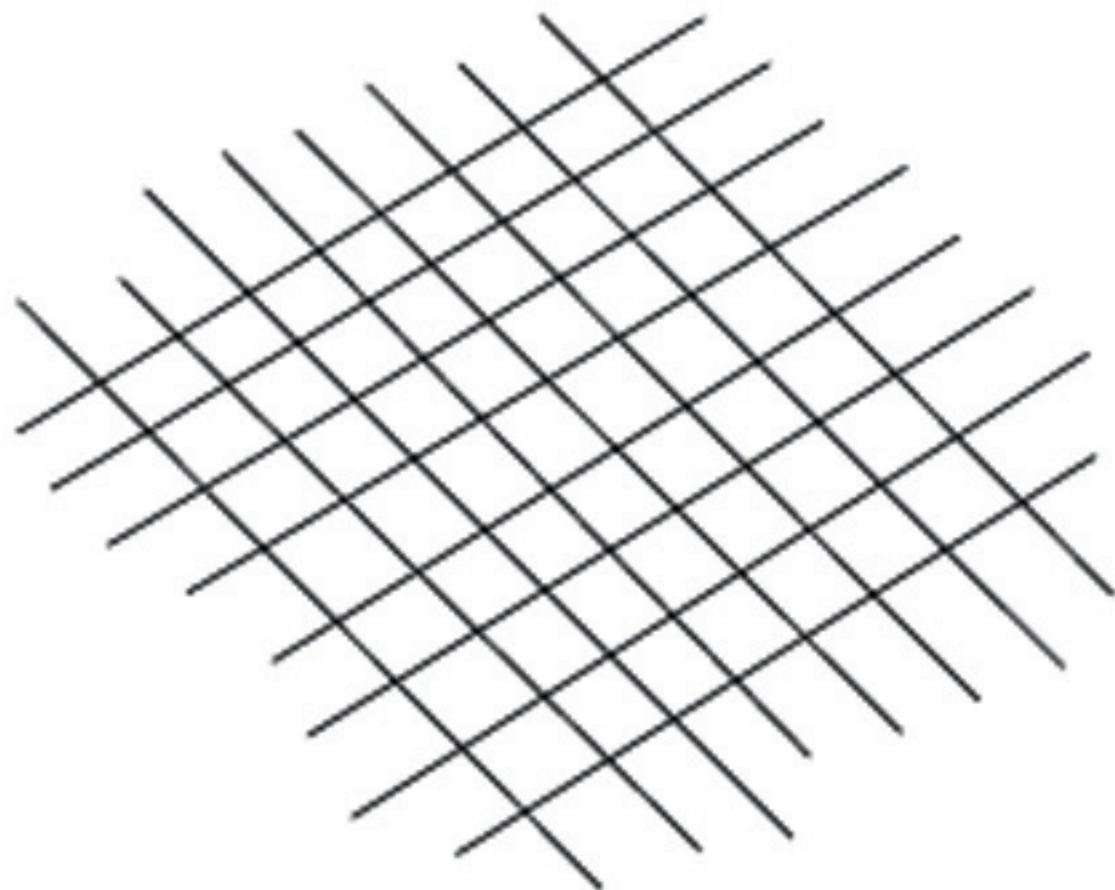
WINDSHIELD MARK ON CASE VEHICLE:

Windshield cut by rescue personnel

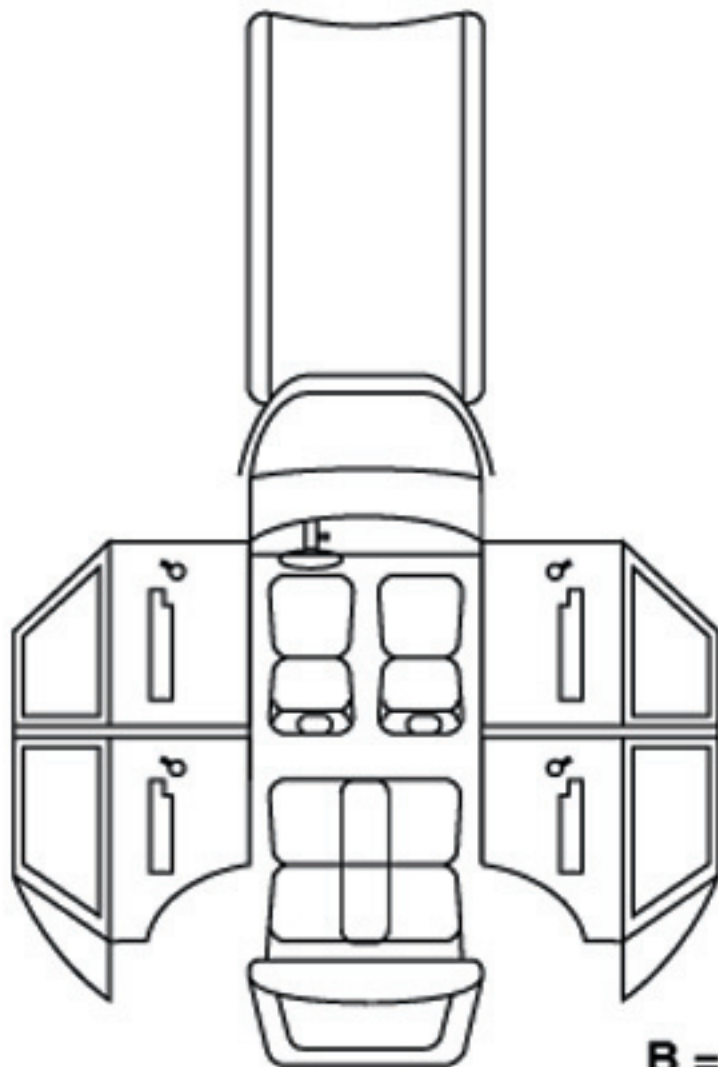
B = steering wheel rim, bent

**D = right front
seatback,
dent**

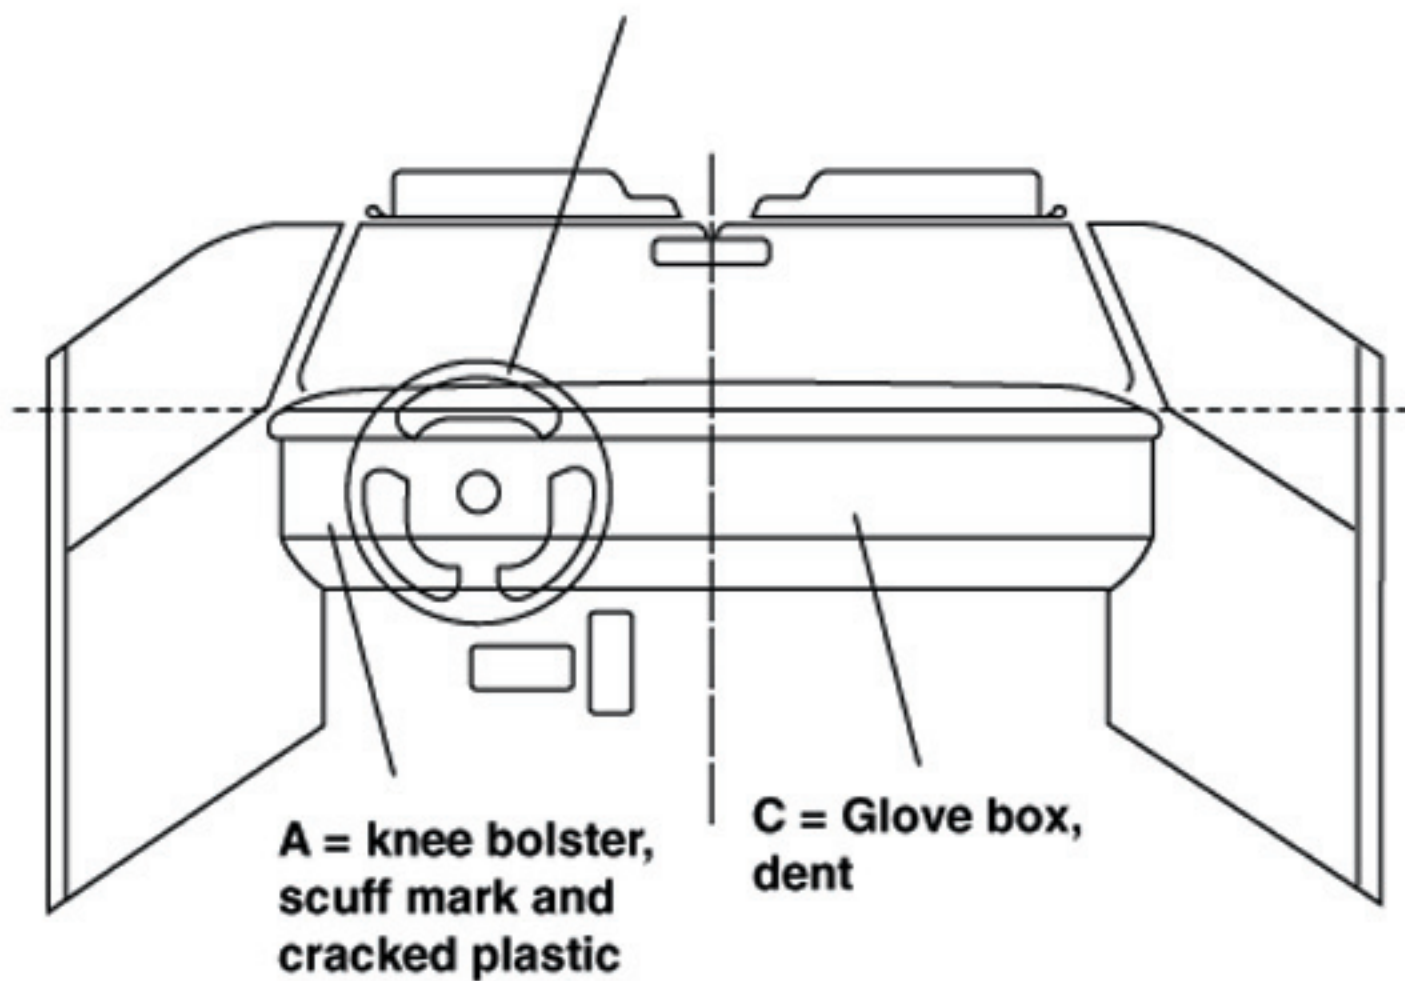
**A = knee bolster,
scuff mark and
cracked plastic**

**C = Glove box,
dent**
